# Tsho Glacial Lake Outburst Flood (GLOF) in Bhutan: cause and impact.

Glacial Lake Outburst Flood (GLOF) is an inherent threat in countries in the Hindu Kush Himalayan (HKH) region and is projected to increase in the face of climate change. One of the recent GLOF events in the region was the outburst of Lemthang Tsho (lake) in Bhutan on 28 July 2015. This paper discusses the cause and impact of the event based on the analysis of multi-temporal satellite images and field observation. The event, which was small to medium in volume, was triggered by the emptying of two supraglacial ponds located upstream of Lemthang Tsho. The area had experienced heavy rainfall till the morning of 28 July. On the same day, at 7:10 am local Bhutan time, a 5.1 magnitude earthquake struck about 177 km southeast of the lake. In the absence of firsthand information from the field, it cannot be confirmed that these two events triggered the lake outburst that took place around 3 pm. However, the possibility cannot be ruled out, either. The rainfall and earthquake are likely to have had a role in triggering the outburst.

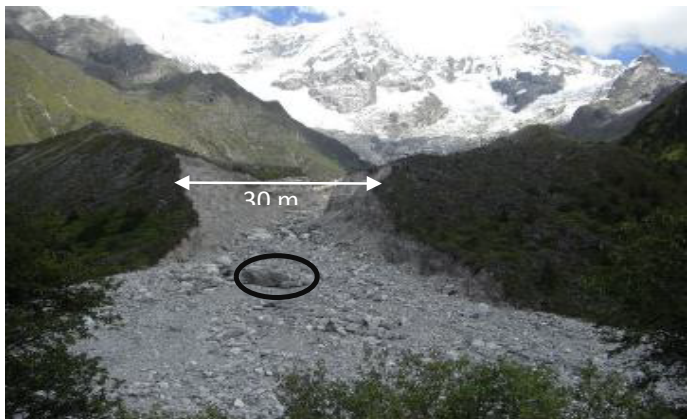
**Photo 2.** Frontal view of the typical V-shaped channel morphology after the breach. A large dislodged boulder can be seen in front of the breached section.

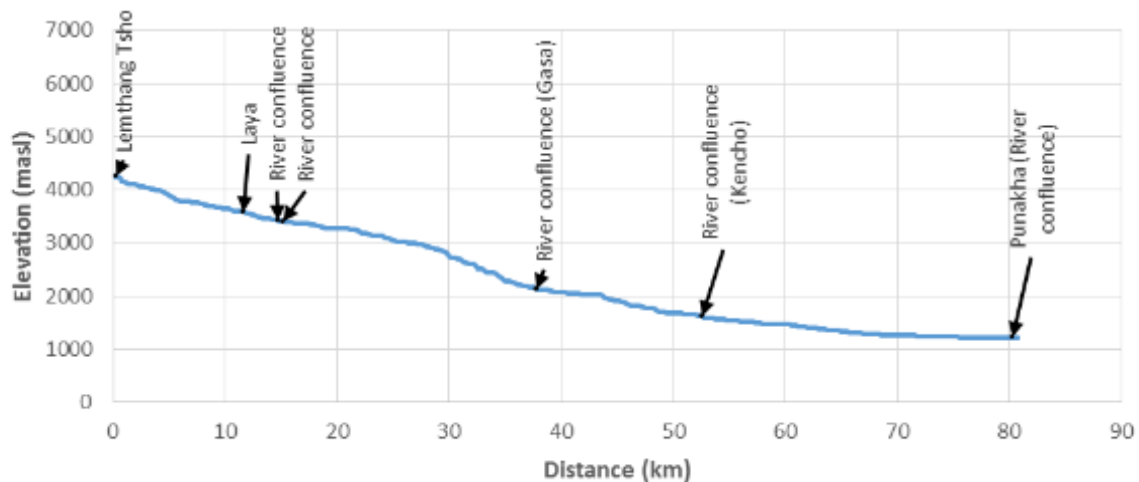
Figure 6. Longitudinal profile of Mo Chu downstream from Lemthang Tsho to Punakha Dzong.
